CRASH INJURY REPORT

U. S. ARMY U-1A
De HAVILLAND OTTER ACCIDENT
Fort Carson, Colorado
16 June 1959

Aviation Crash Injury Research
of the **F**light **S**afety **F**oundation

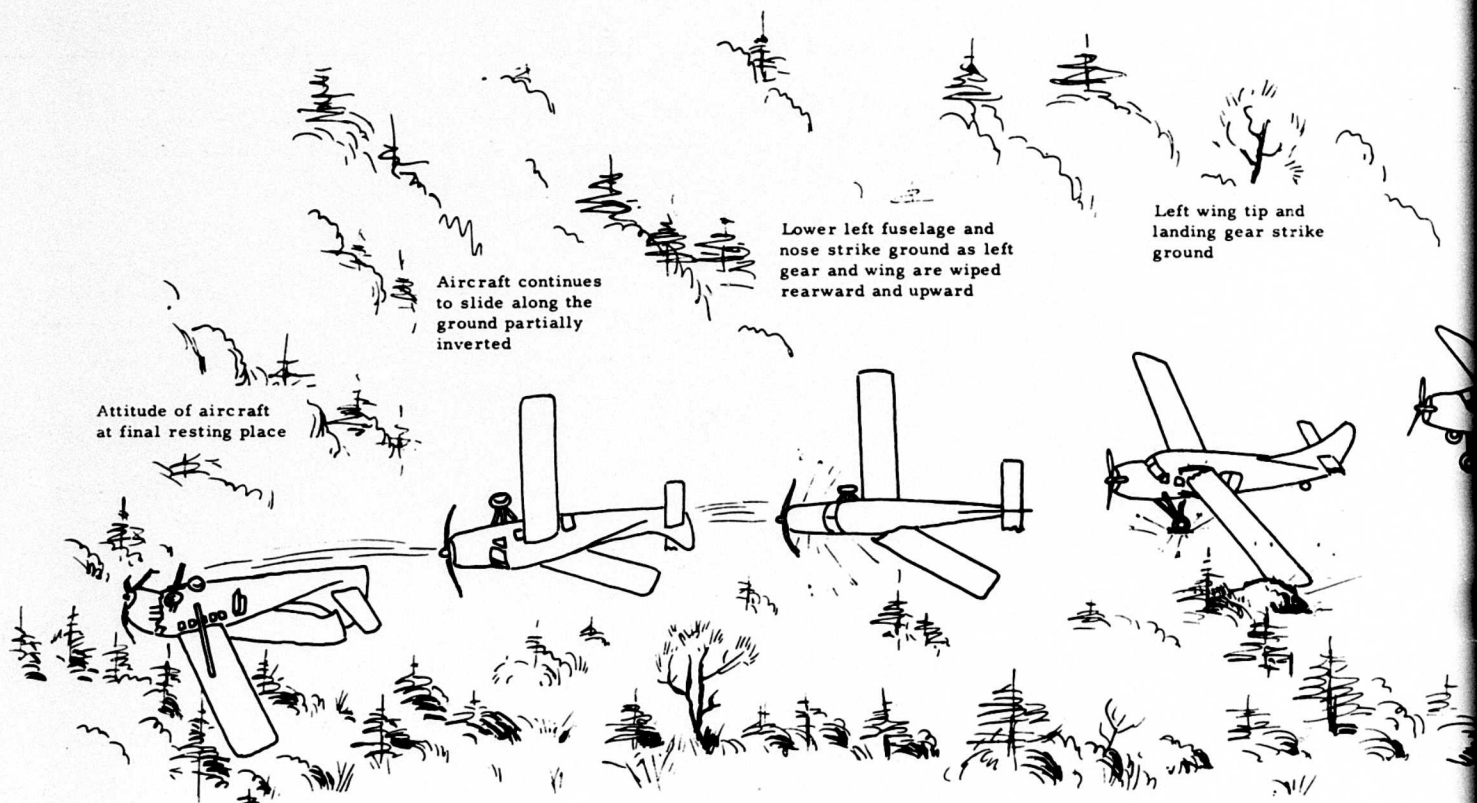
KINEMATICS DIAGRAM - U. S. Army U-1A De Havilland Otter Accident

As the aircraft descended into the canyon, the left horizontal stabilizer struck the trunk of a dead tree, shearing off part of the stabilizer and elevator. (See Kinematics Diagram, p. 9, and Fig. 12, p. 21.) At the time of this impact the aircraft was flying at minimum flying speed in a nose-high attitude with the left wing slightly down. The impact caused the aircraft to yaw approximately 10 degrees to the left and to begin rolling to the left while continuing to move forward and downward.

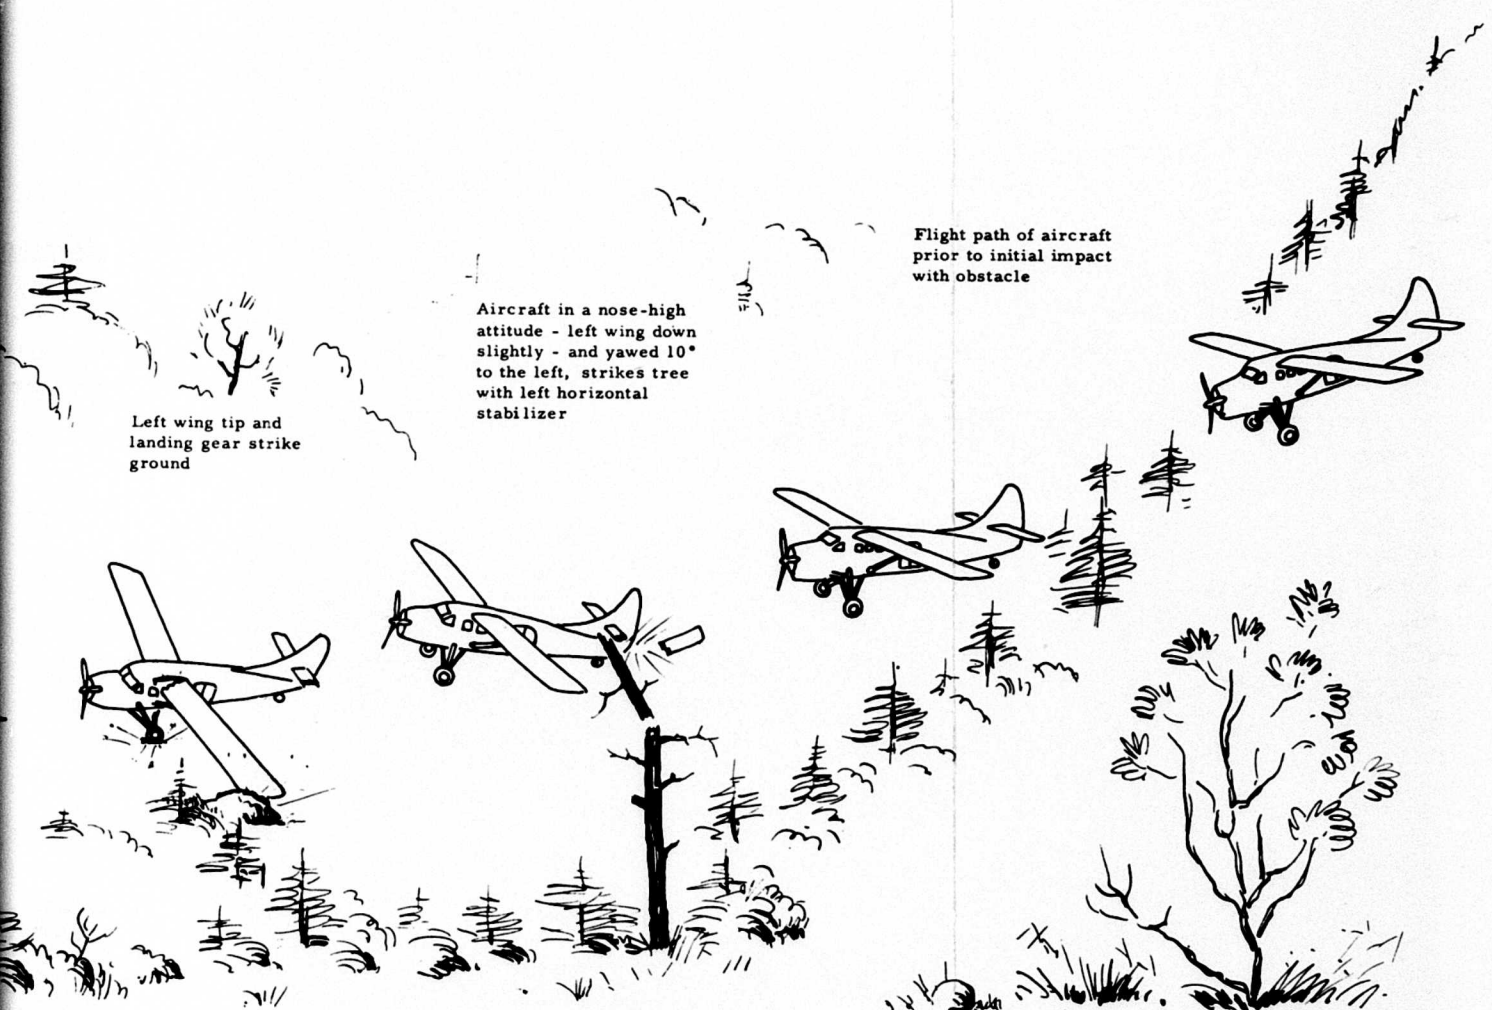
1A De Havilland Otter Accident, Fort Carson, Colorado, 16 June 1959

Left wing tip and
landing gear strike
ground

Aircraft in a nose-high
attitude - left wing down
slightly - and yawed 10°
to the left, strikes tree
with left horizontal
stabilizer

Flight path of aircraft
prior to initial impact
with obstacle

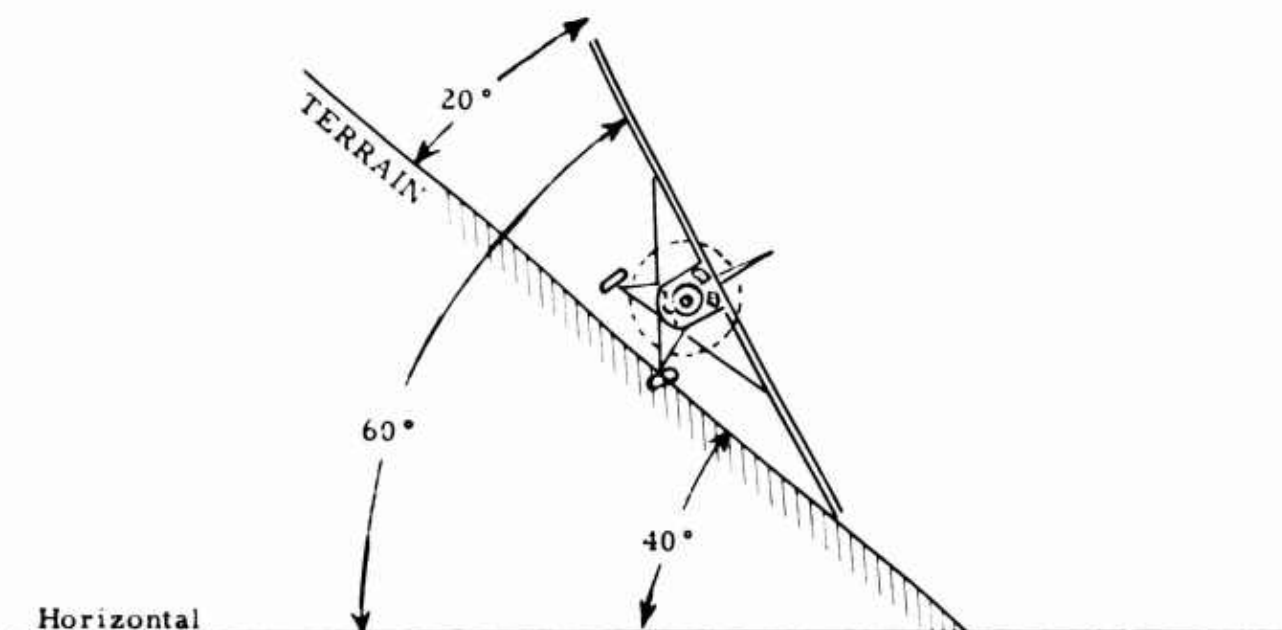
View looking rearward along the flight path, showing the roll attitude of the aircraft in relationship to the horizontal and the terrain at principal impact with the ground.

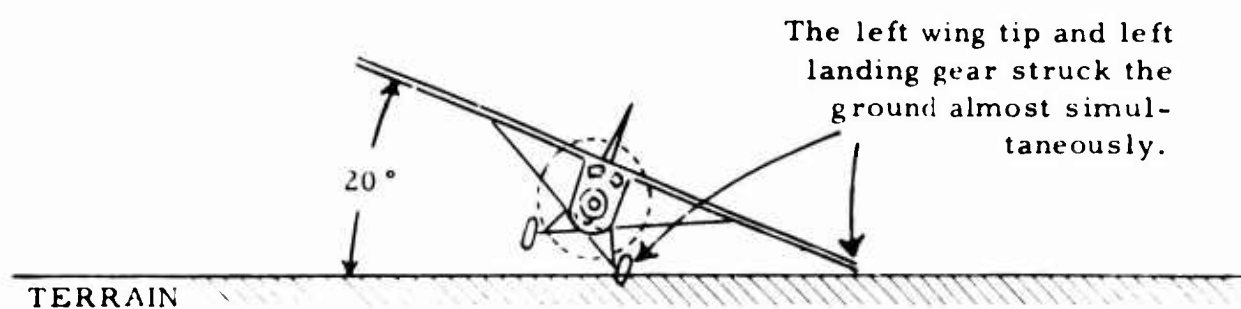
View showing the wing-down attitude of the aircraft in relationship to the terrain at principal impact. (Slope of the terrain has been rotated to the horizontal.)

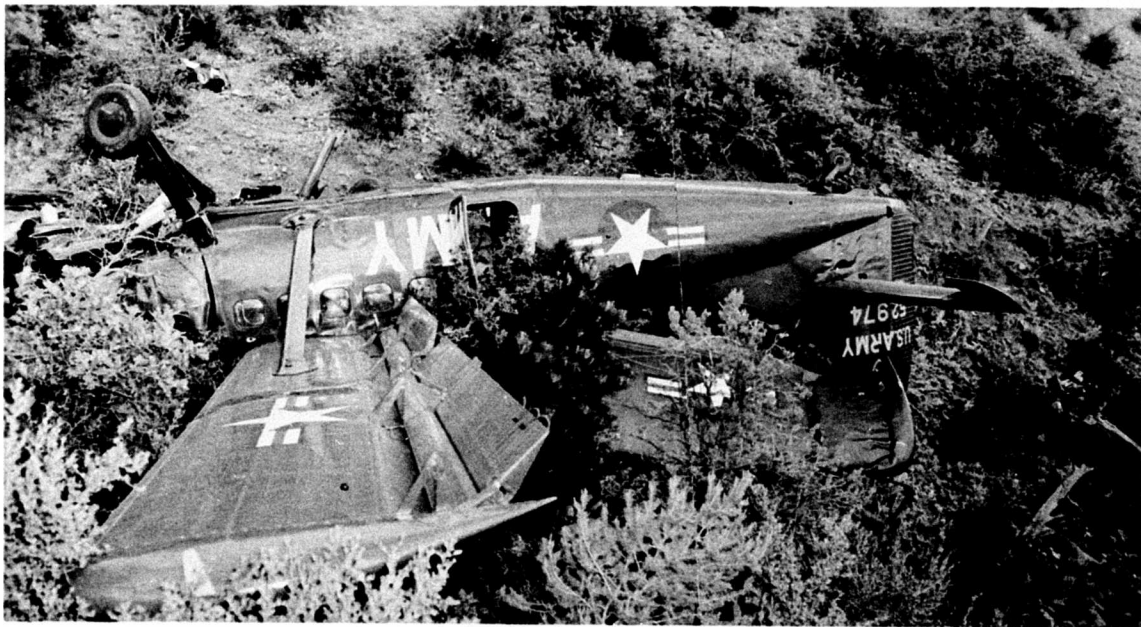
As the aircraft struck the ground, the left landing gear was wiped rearward and upward into the bottom of the fuselage, rupturing the fuel cells in the belly and causing a large section of the cabin floor to heave upward. The left wing was rotated rearward and upward as the aircraft continued to roll to the left, causing inward displacement of the cabin wall and the ceiling structure adjacent to the wing root. The aircraft continued to slide along the ground progressively rolling over to a partially inverted position before coming to rest about 60 feet from the point of initial ground impact. The left wing came to rest under the aircraft. (See Fig. 2, p. 15.)

Fig. 2. Final position of wreckage after the crash (composite photo).

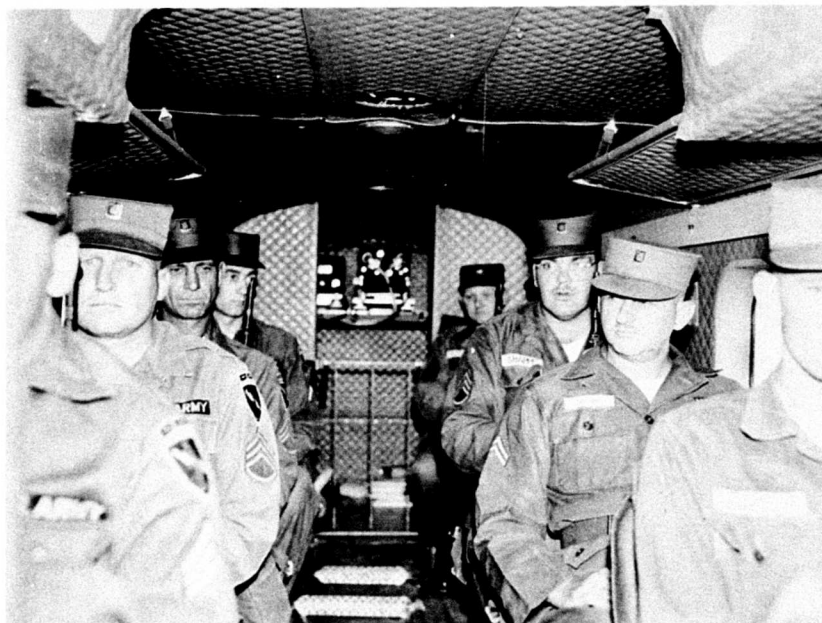
Fig. 13. View looking aft in the cabin of an intact U-1A Otter aircraft, showing the seating configuration utilized for the transportation of combat troops.

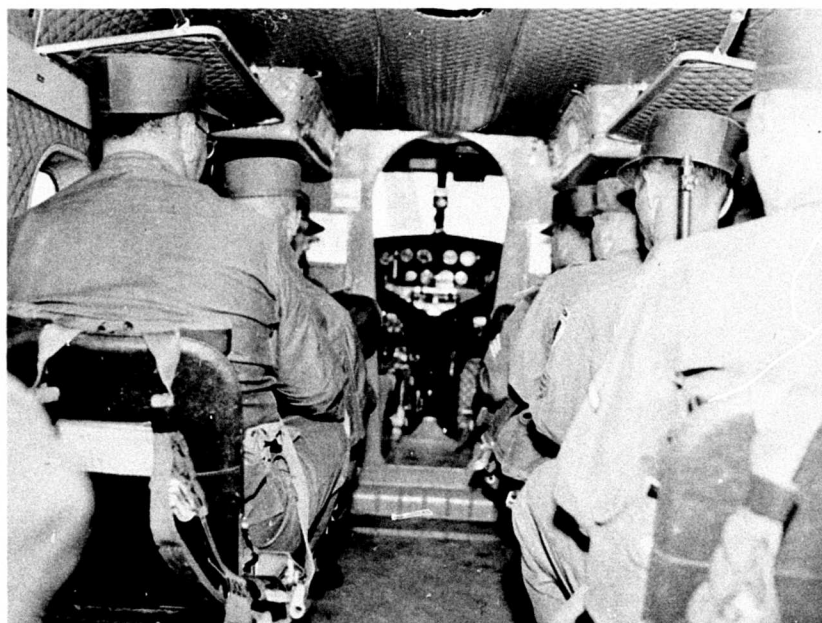
Fig. 14. View looking forward in the cabin, showing the seating arrangement utilized in transporting combat troops.

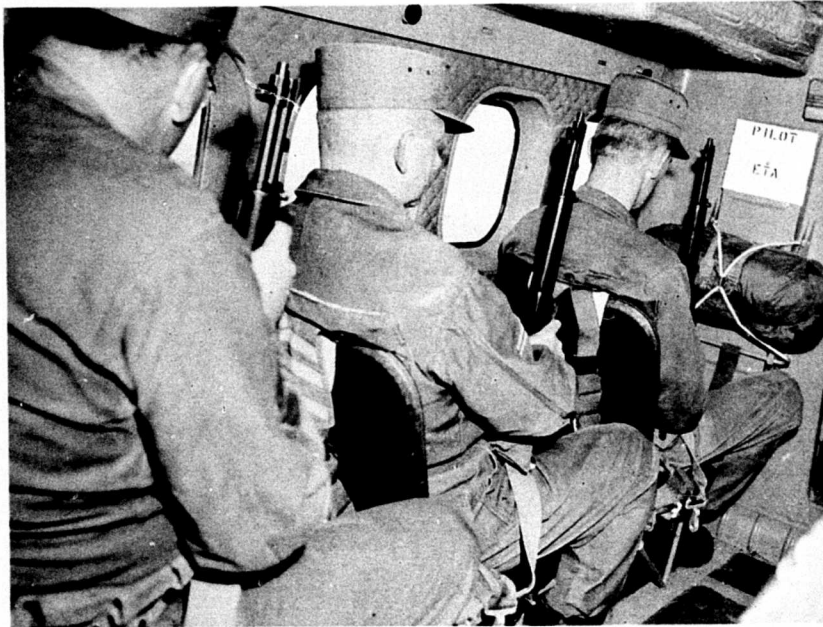
Fig. 15. View of the left-hand cabin area, showing the manner in which combat troops position their weapons during flight. (Passenger occupying the rearmost seat is not shown.)

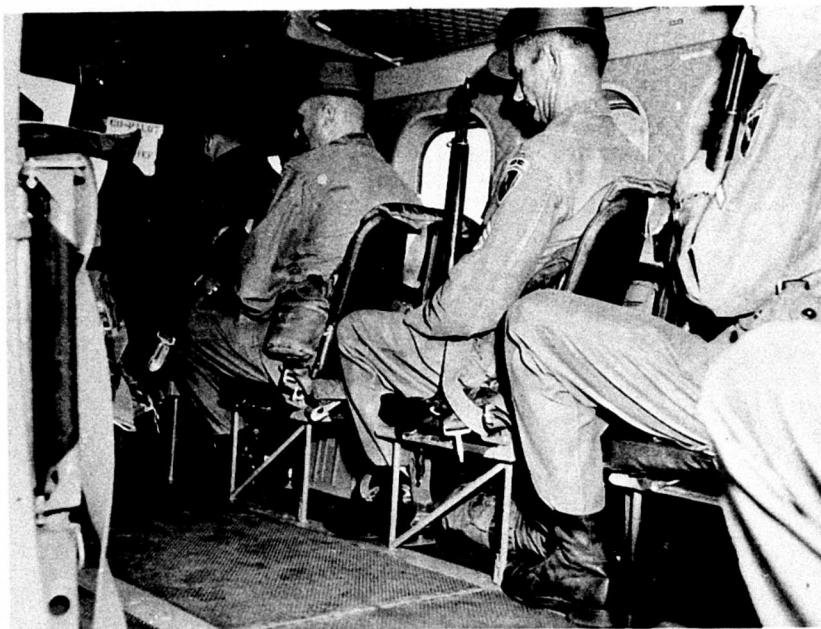
Fig. 16. View of the right-hand cabin area, showing the seating configuration utilized in transporting combat troops. (Note positioning of weapons, with muzzle near face and head.)

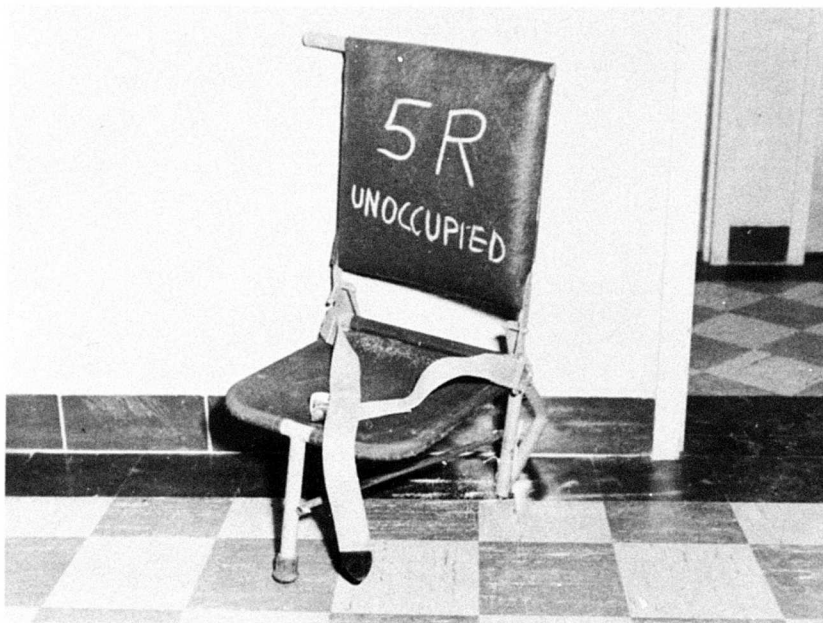
Fig. 53. Seat 5R was unoccupied and folded up against the rear partition.
